New York State Department of Transportation

PIA Safety Flag NB23CTW007

BIN: 1065318

Feature Carried: 278I278IX2M23027

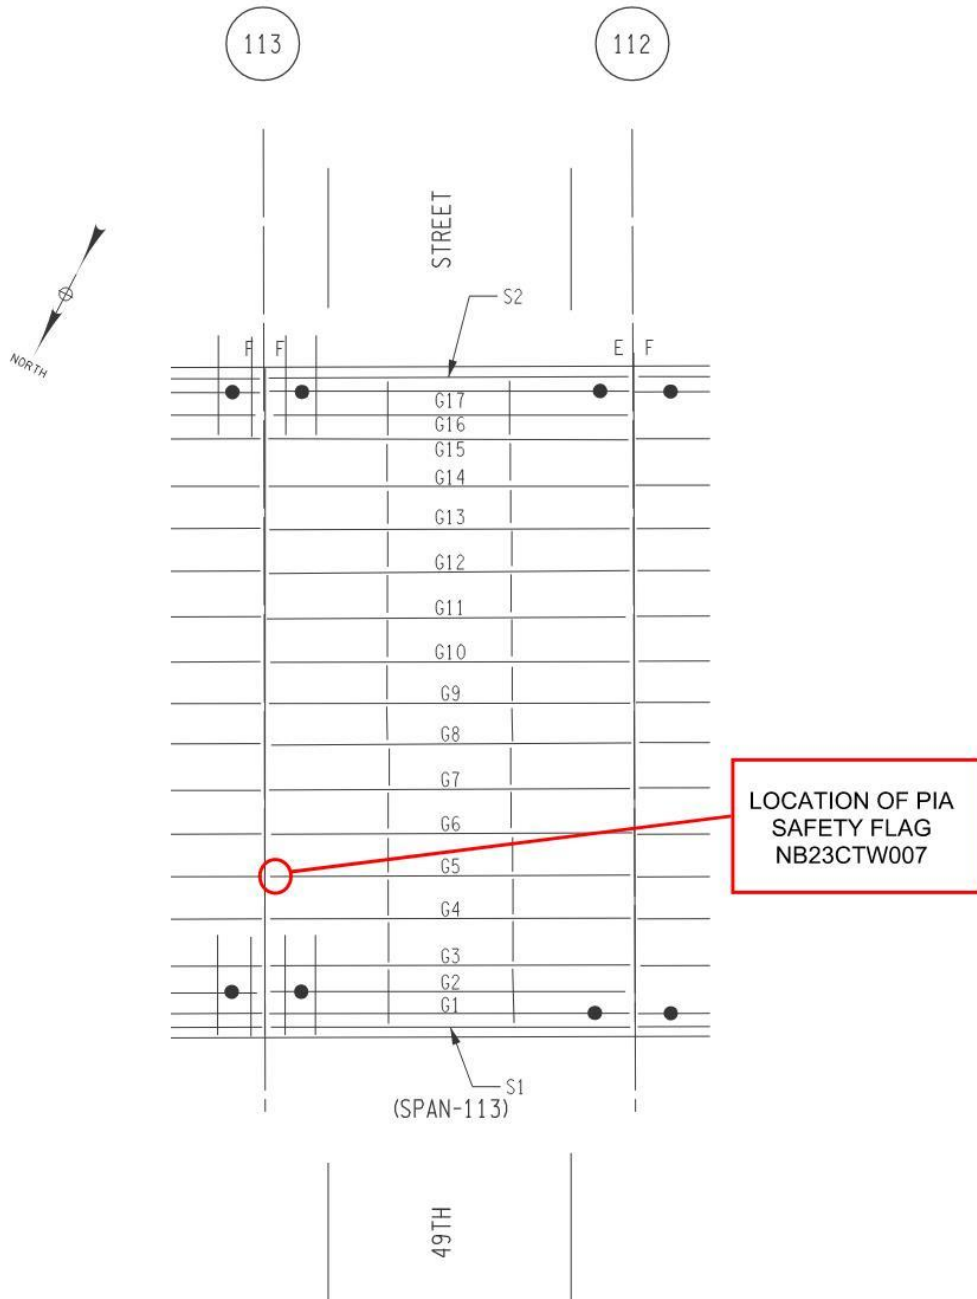
Photo Number: 1

This PIA Safety Flag No. NB23CTW007 is a New Flag.
Location: Span 113, Pier 113, Column C1 at the base.

**Attachment Description: Flag Location Plan.**

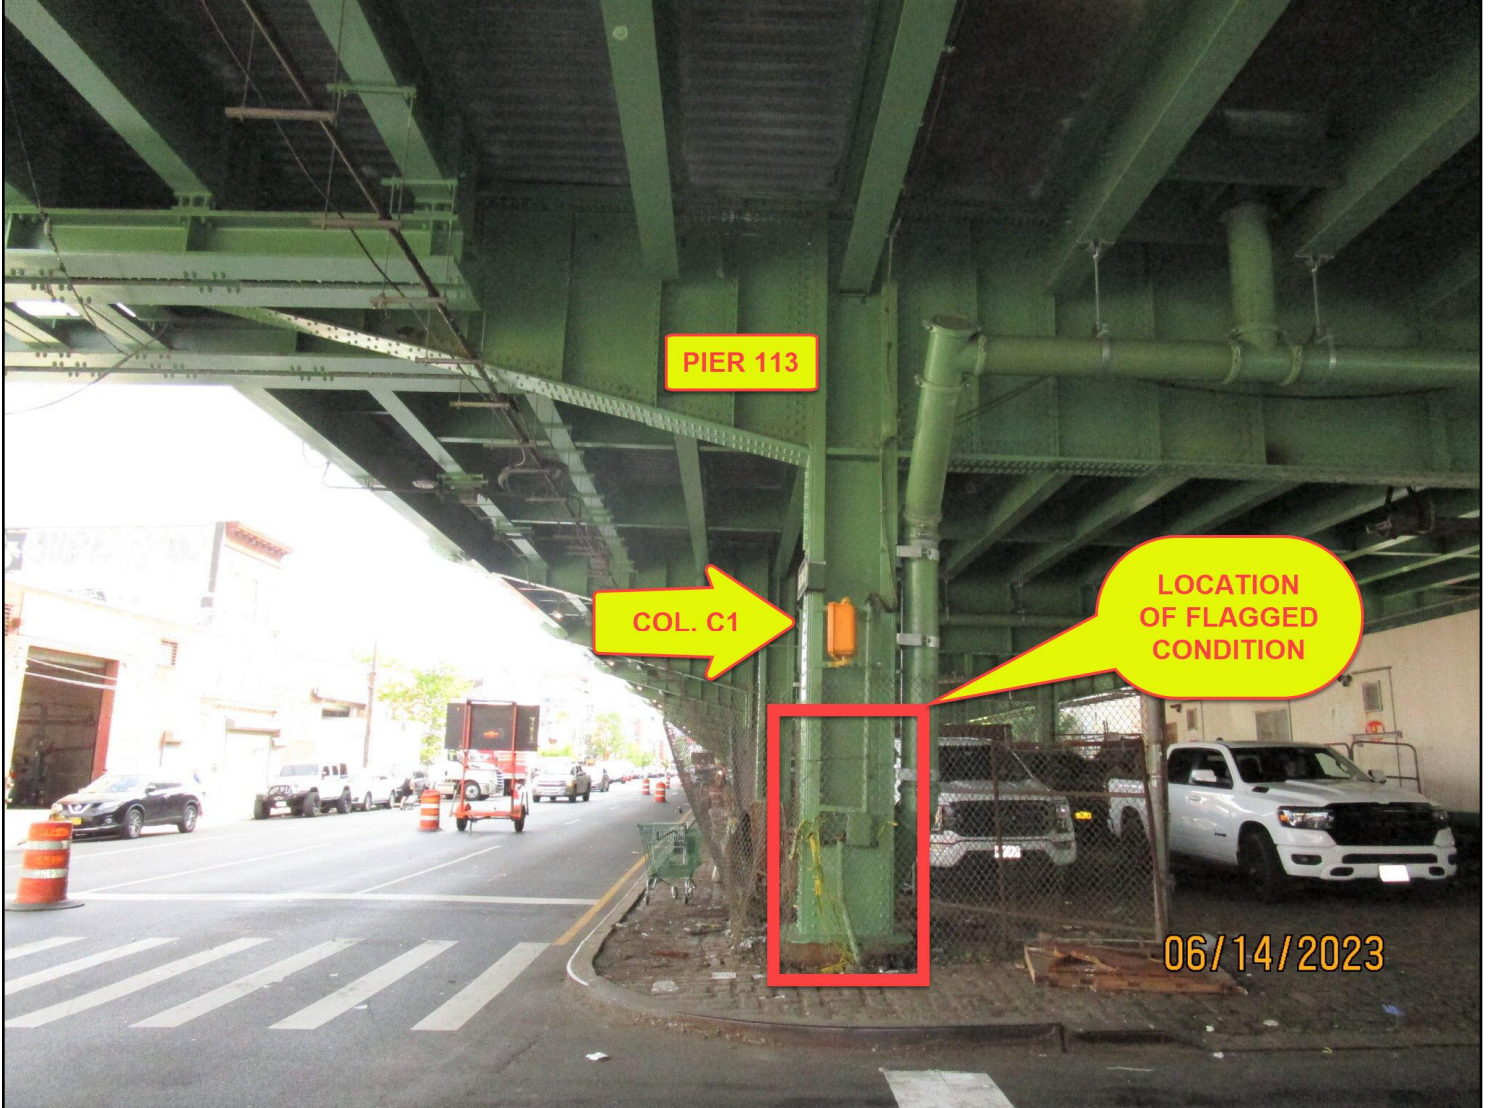
Photo Number: 2

Attachment Description: General view of Flagged location. Looking End.

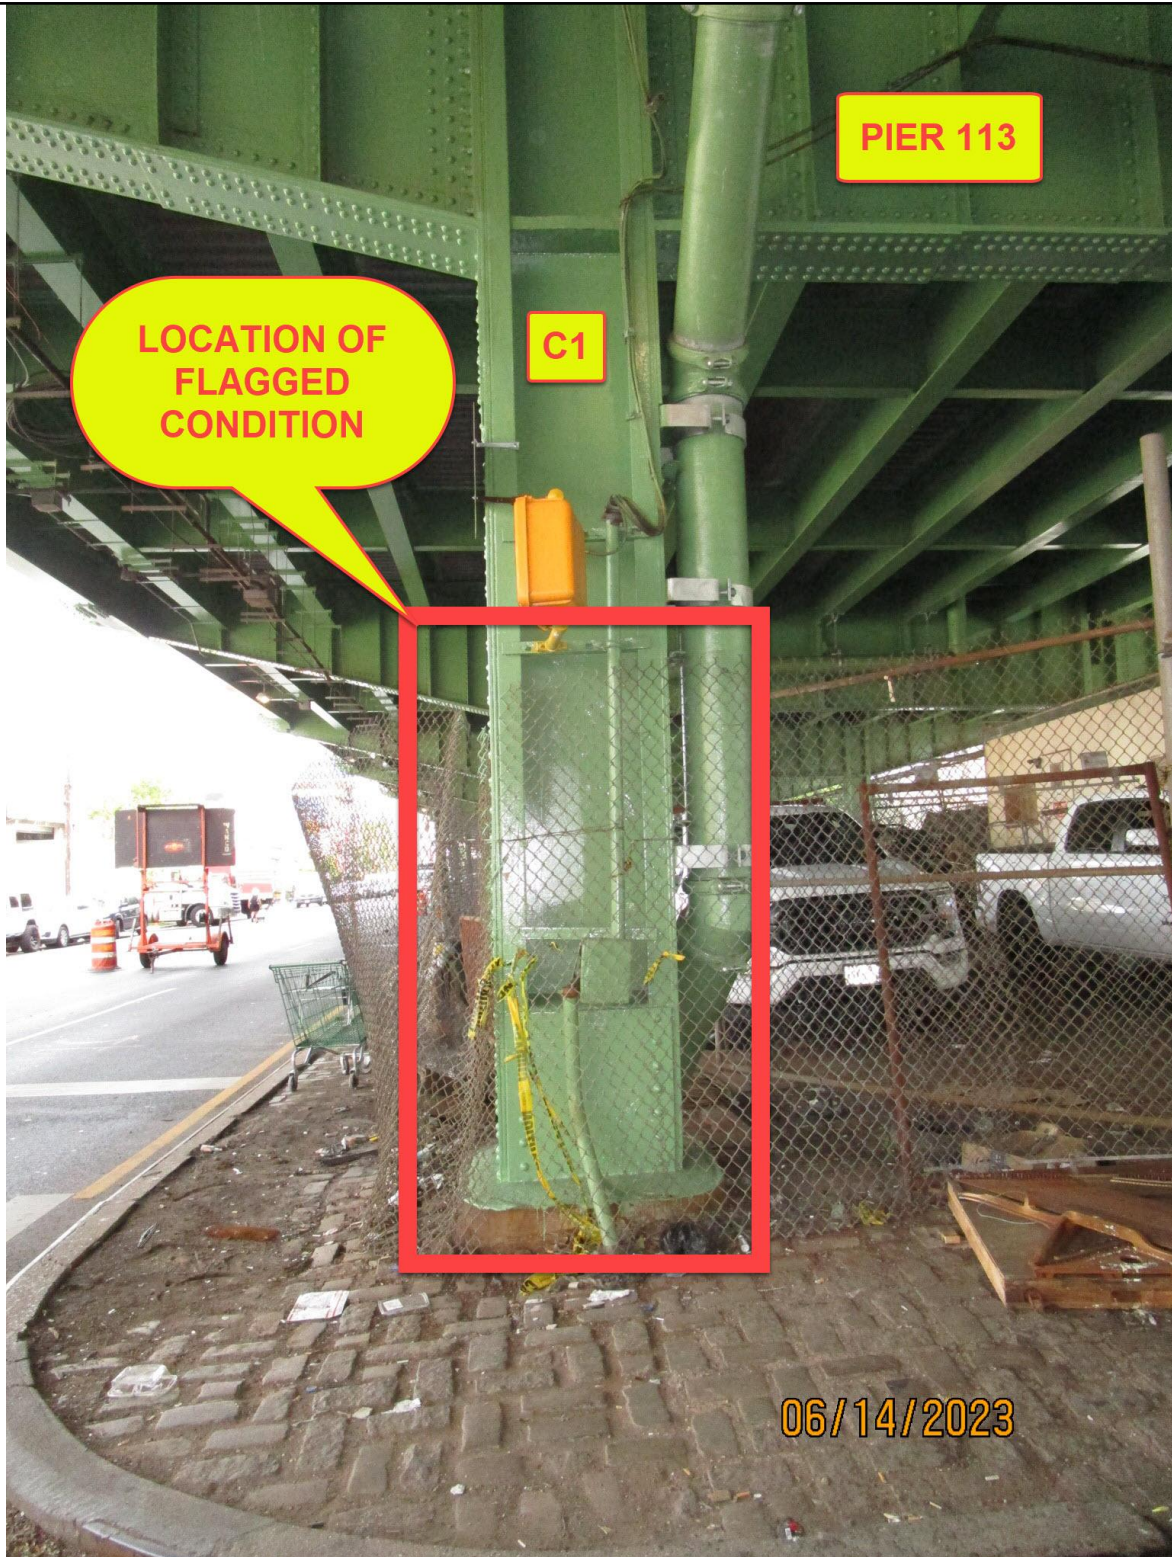
Photo Number: 3

At Span 113, Pier 113 Column C1, Begin face, there is a corroded and broken electrical junction box which exhibits exposed live wires. The condition is at the base of the column, and is accessible by the public.

Attachment Description: Location of Flagged condition at Pier 113, Column C1. Looking End.

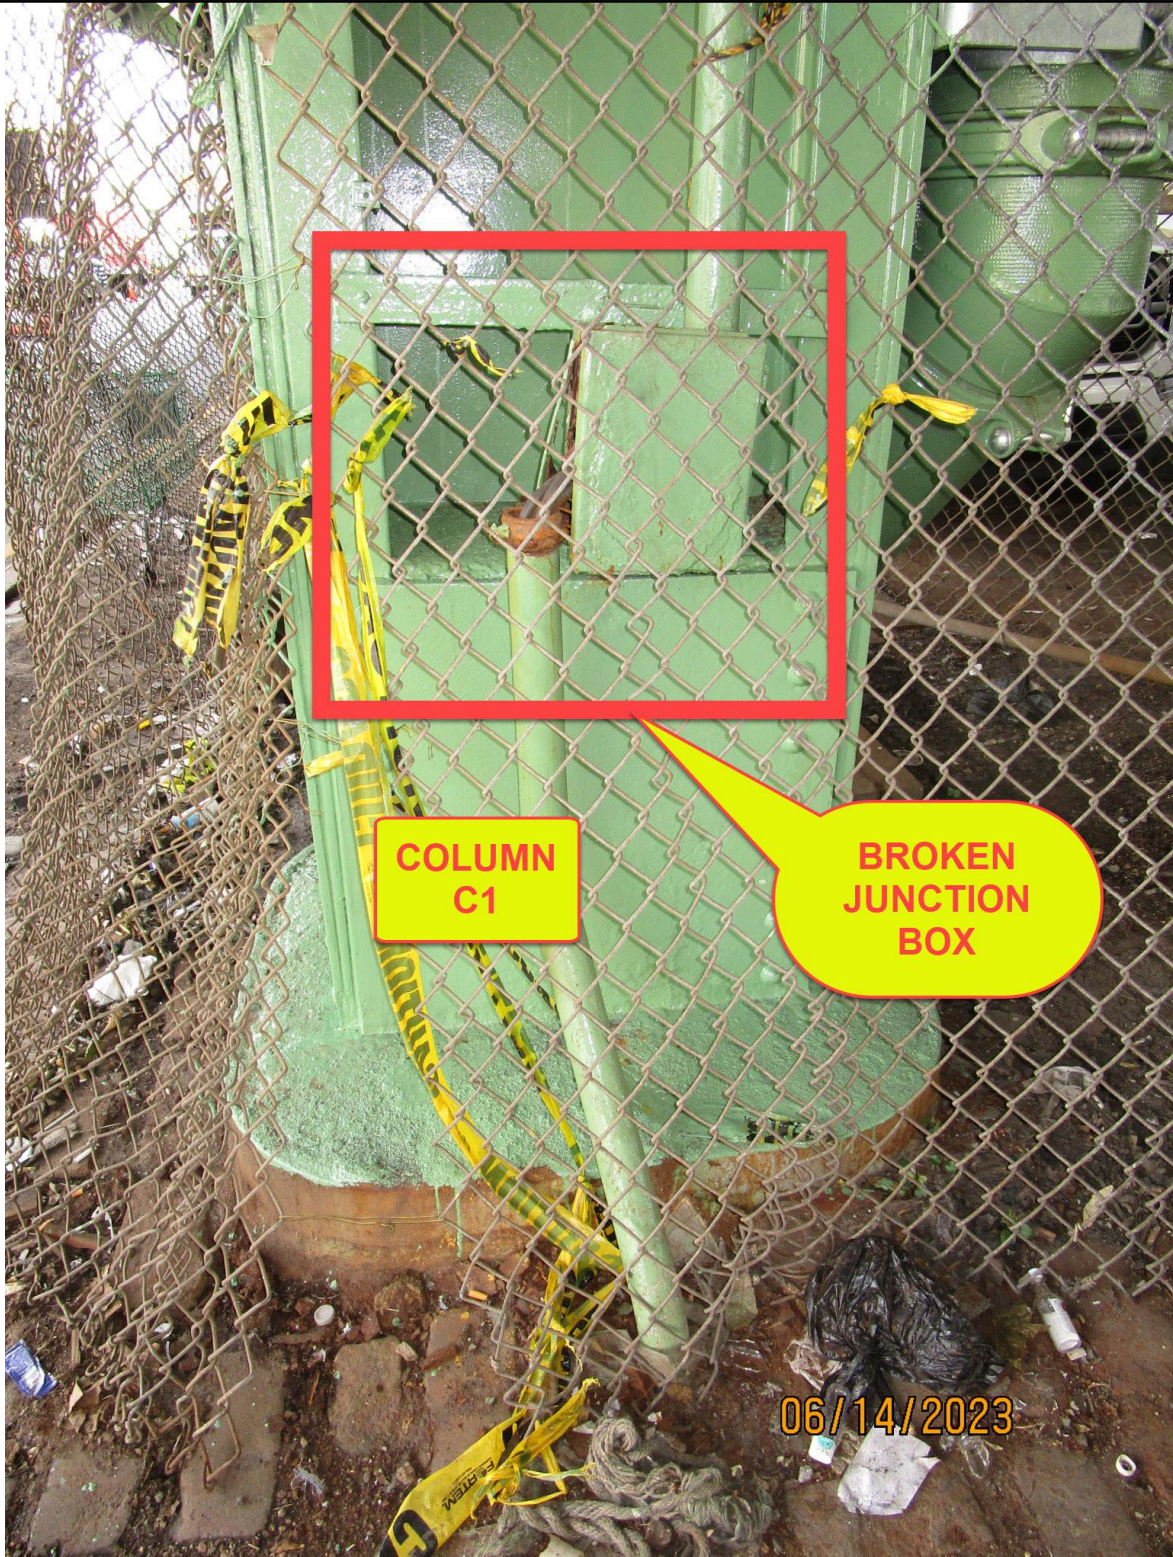
Photo Number: 4

Attachment Description: Close-up view of the broken junction box at Column C1. Looking End.

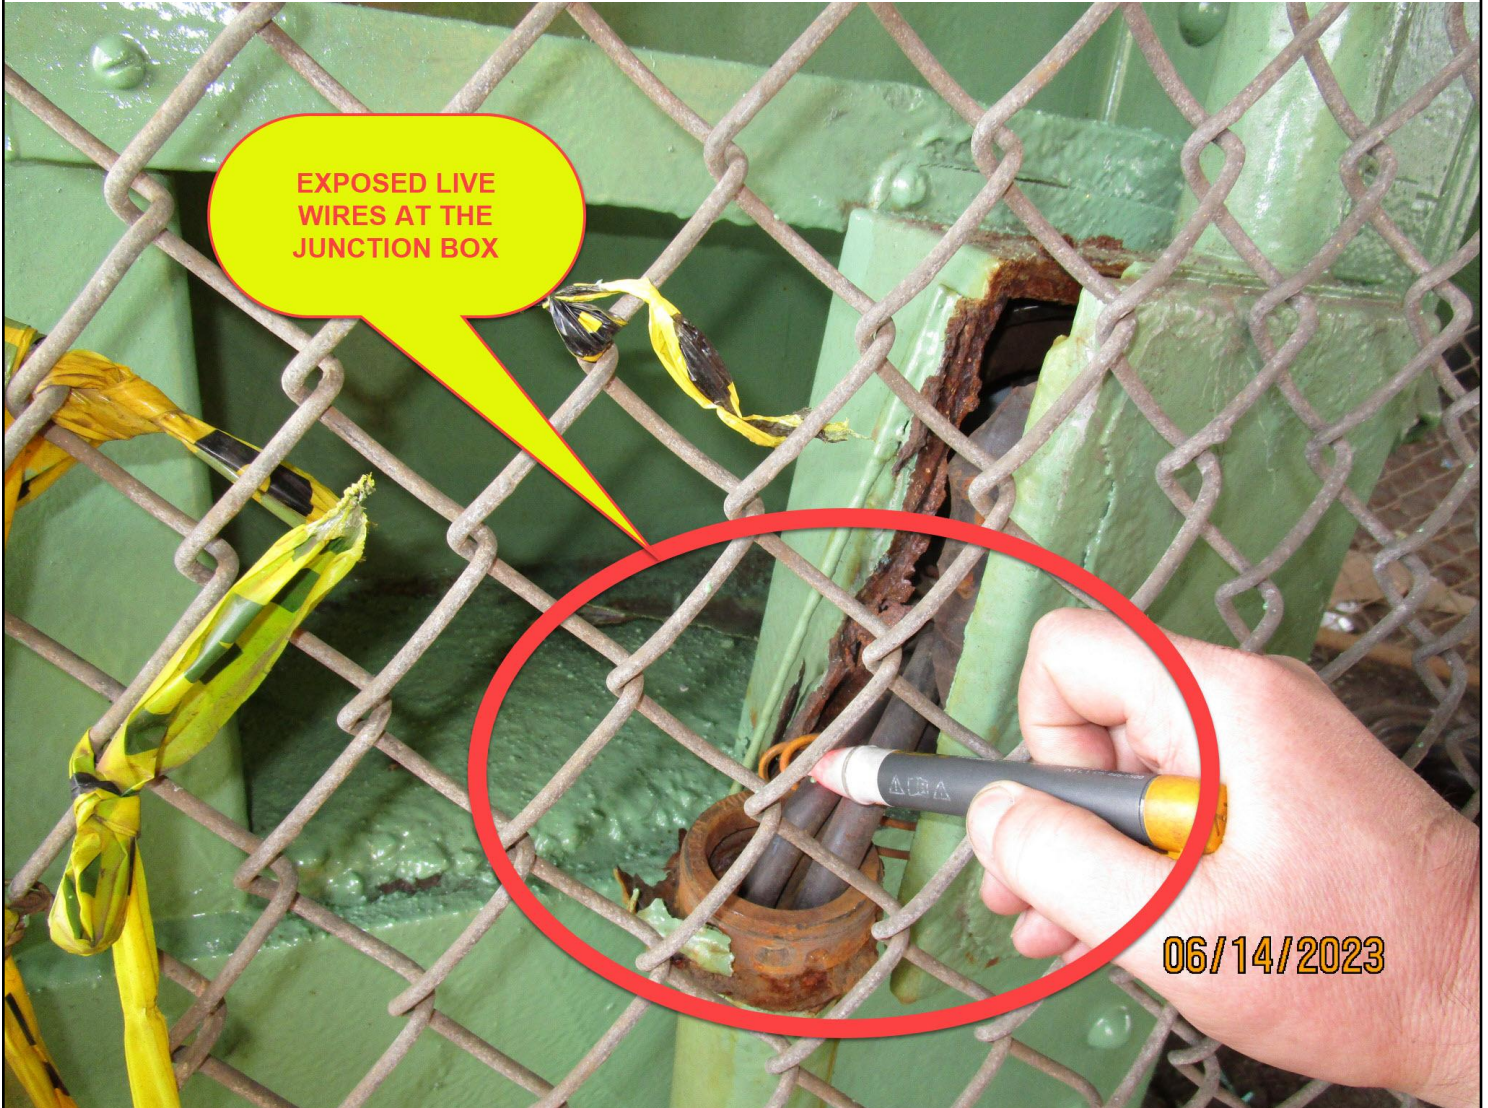
Photo Number: 5

Attachment Description: Non-contact voltage detector indicates live wires at the junction box. Looking End.
